# Intel<sup>®</sup> Pentium<sup>®</sup> 4 Processor Specification Update

Release Date: October 2001

Order Number: 249199-014

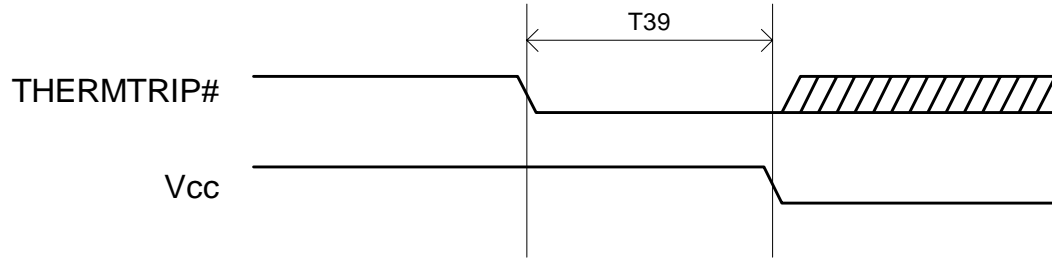
The following figure will be added as Figure (new). THERMTRIP# Power Down Sequence

Assertion of THERMTRIP# (Thermal Trip) indicates the processor junction temperature has reached a level beyond which permanent silicon damage may occur. Measurement of the temperature is accomplished through an internal thermal sensor which is configured to trip at approximately 135°C. Upon assertion of THERMTRIP#, the processor will shut off its internal clocks (thus halting program execution) in an attempt to reduce the processor junction temperature. To protect the processor, its core voltage ( $V_{CC}$ ) must be removed following the assertion of THERMTRIP#. See Figure (new) and Table 13 for the appropriate power down sequence and timing requirements. Once activated, THERMTRIP# remains latched until RESET# is asserted. While the assertion of the RESET# signal will de-assert THERMTRIP# , if the processor's junction temperature remains at or above the trip level, THERMTRIP# will again be asserted after RESET# is de-asserted.

$T39 < 0.5$  seconds

Note: THERMTRIP# is undefined when RESET# is active
